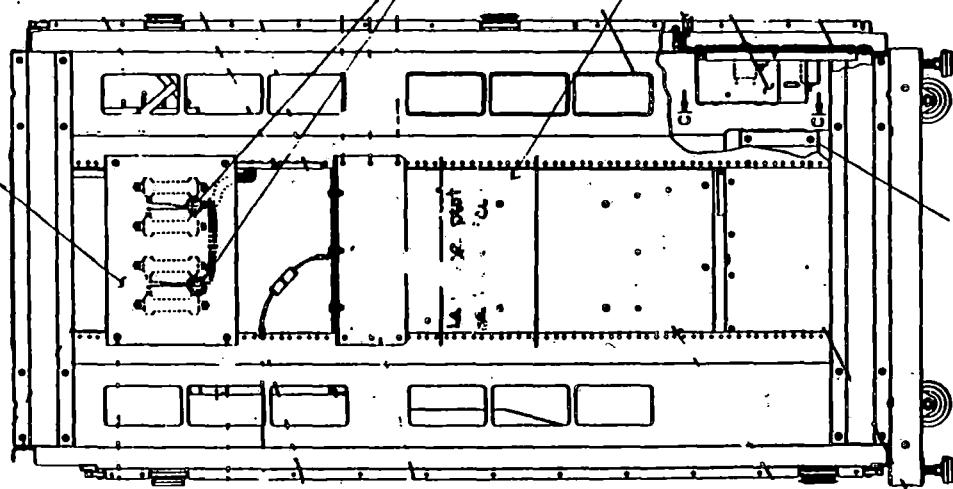
PN 40-23417-01 = 8300/8800
-02 = 85xφ

On Nautilus CPUs we have begun to see a spate of problems where the EMM initiates a power standby shutdown with a DM CODE 19 MOD OK NOT ASSERTED reporting MOD H(or F) as bad.

This failure is caused by the cabling of the load resistors on regulators F and H (H only on 85XX). The black wires are badly supported and can come in contact with the resistors. The sheath then melts and as a result short circuits causing intermittent faults which are difficult to isolate.

If the wires are not melted then add a wire wrap to tie the black wires to the red and purple wires. If the sheath is too badly damaged then change the wires p/n 70-23417-01 for 8700/8800 and 70-23417-02 for 85X0 systems. Add the tie-wraps before reassembling.

Refer to the attached print for location.
