CUSTOMER ENGINEERING

# news LETTER

January 31, 1956

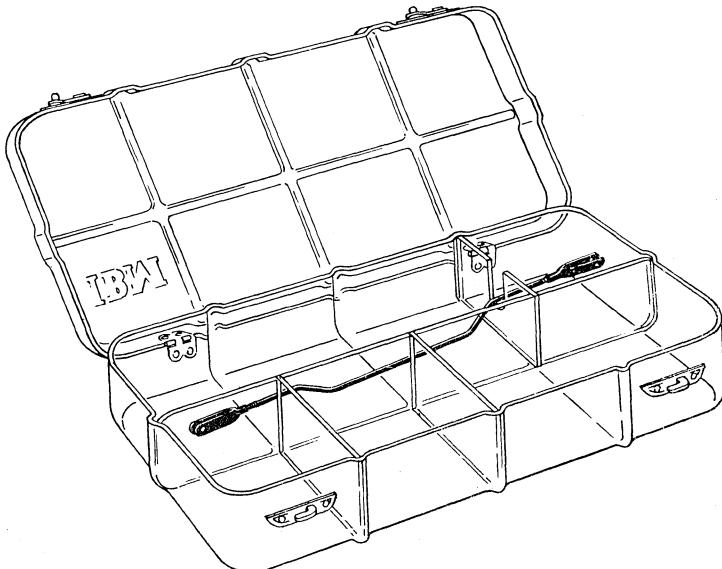
The large plastic parts box can be made to accommodate long links by cutting a hole or, preferably, a slot in one of the plastic partitions.

The cut can easily be made by using a pen knife or razor blade.

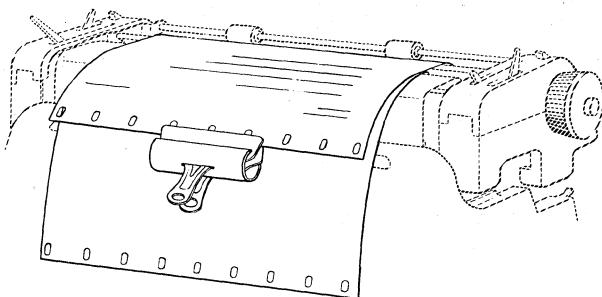
Some heavy stock offset paper masters have a tendency to bulge, particularly at the top. This causes the master to drag on the paper bail shaft and/or line gage card holders resulting in smudged copy. This condition can be alleviated by weighting the master at the leading edge. As illustrated, a heavy paper clamp works very effectively in accomplishing this.

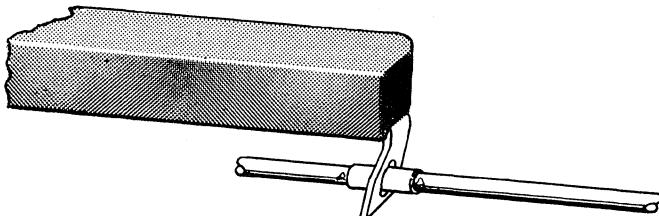
Here is a method that may be employed to reduce space bar noise in case of equalizing rod rebound. Form the R. H. space bar bracket to one side to reduce clearance to the plastic bushing. The L. H. bracket slot may be closed slightly if required. Be certain the space bar does not bind as a result of these forming operations.

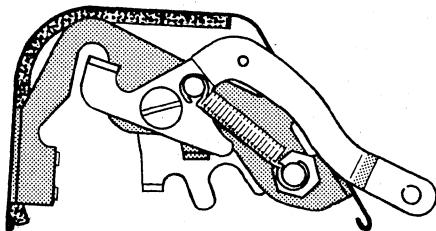
A tendency for the Model B cam anchor rod to lift out of the pin wheel yokes may be caused by a bind in the pin wheels. If the pin wheels are free of binds and the cam anchor rod still comes out of the yokes, additional tension may be applied to it in the following manner:

1. Replace the two paper table mounting plate screws (#196299) with two of the studs for mounting the rear line lock bell-crank to the left side frame (part #1096742).
2. Remove the bottom of the cam anchor rod springs from the paper table mounting plates and hook them in the slot of the studs installed above.

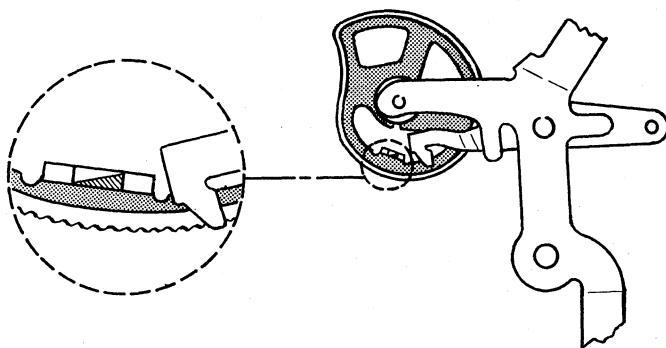
It has been found occasionally on special machines, such as Toll Billers and Partial Carriage Return typewriters, that operator timing can cause carriage return cam lock-up. This lock-up occurs if the carriage return key is operated at the precise instant the cam lug is in the path of the non-repeat lug of the release lever. The symptom of this trouble is a cam that is found locked up because the non-repeat lug of the release lever is engaged on the end of the cam lug. To overcome this situation, the lug may be ground as shown. Remove the triangular shaded area in the illustration. This helps the cam to be moved back into the power roll and prevents this lock-up. The most practical method of accomplishing this is with a small electric hand grinder with a flat abrasive disc.

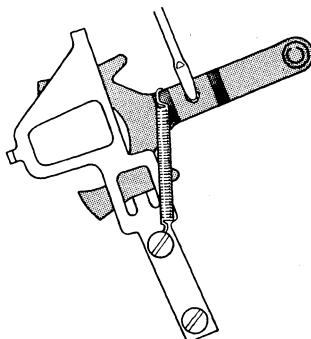
When all adjustments are correct but trouble persists, service calls resulting from the operator 'beating the shift' may often be solved in the following manner. First, remove the right hand shift key lever spring. Second, attach a cam spring, part #1107795, from the top of the pusher lever, (in front of pusher link) down to the top screw of the pusher retainer. It will be necessary to form one loop of the spring to hook over the pusher lever.

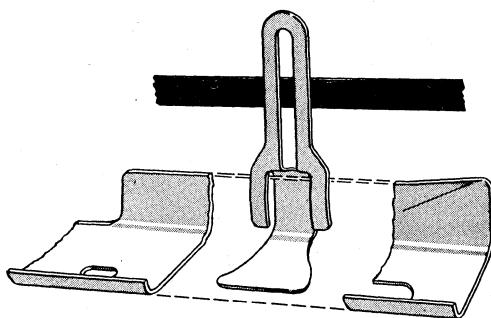
After an acetate ribbon has been struck by several type bars it assumes a static charge and may cling to the platen; sometimes causing smearing and erratic ribbon feed. In order to overcome this difficulty, a pin feed finger, Part No. 304786, may be formed and attached to the left side of the front rail dust cover, as shown in the illustration. Locate it above the segment guide spring. This will prevent the ribbon from clinging to the platen and improve acetate ribbon performance.

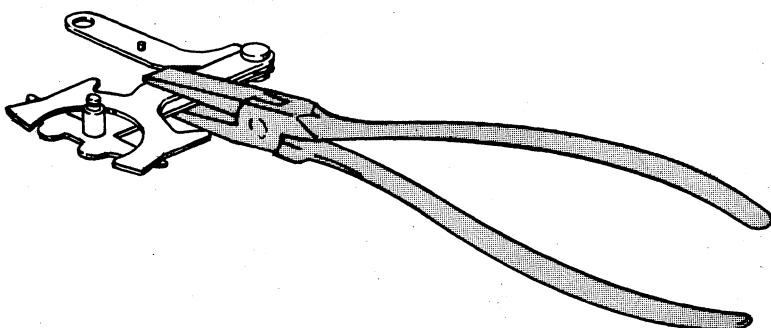
Looseness in the pusher and lever assembly, especially in the rivet, may permit the assembly to become locked. This results in the T member hanging on the pusher. If you should encounter this condition, remove the pusher and lever assembly and form as illustrated. This will prevent lock up. This condition is being corrected here at the Plant.

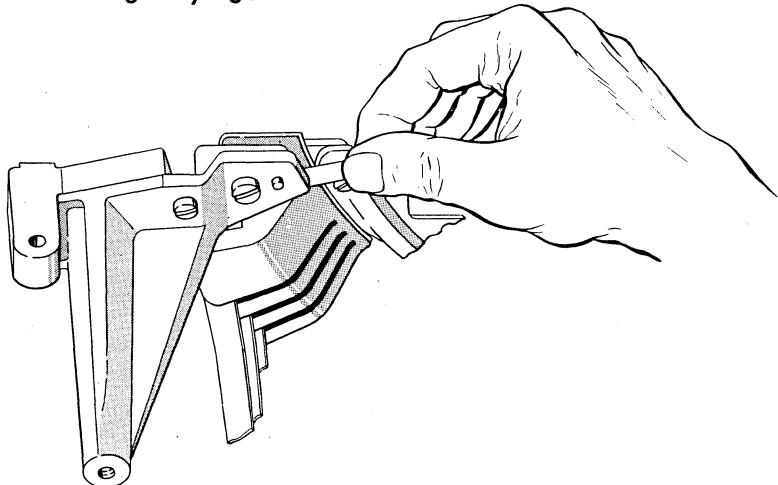
Earlier this year, we were informed by the Pittsburgh ET Customer Engineers of a more successful method of overcoming this problem. We have since supplied information describing this method to several other Branch Offices and the "feed-back" has been gratifying.

Specifically, the problem involves certain applications, but will improve any application where the results are not up to acceptable standards. One of the most common problems is Elite type with carbon ribbon attachment where the application involves original bond and several carbon copies. This same type with carbon ribbon, where the application involves a thin bond or Airmail original with carbon copies, is another example. The upper-case is too dense and often cuts through the

1. Experimentally, place 1 to 4 thicknesses of ordinary bond paper shims between the segment and segment support. (The shims should be about 1/4" wide by 3/4" long.) As you add shims, test the results of typing on three sheets of bond to determine the proper number of shims to add. Adding the shims causes the lower portion of the segment to move toward the rear of the machine.

It is the consensus of the several Branch Offices who have tried this method that it is superior to shimming the segment guide springs as contained in ET CEM No. 272. We have found that shimming the segment as described above, actually changes the velocity of the typebars so that both upper and lower case characters strike the paper with the desired amount of impact.

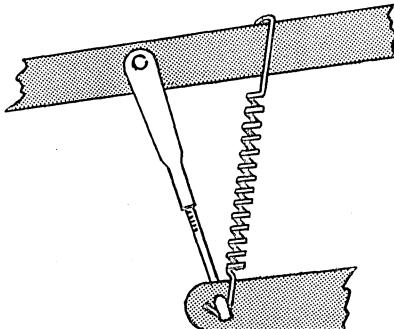
Repeating Space Bar Cams on earlier Model A ET's may be prevented by attaching a key leverspring part # 1107794, between the cam release lever and key lever. As shown in the illustration, the spring is hooked over the end of the cam to key lever connecting link and the other end is formed to fit over the key lever.

Attached in this manner, the spring will take up any accumulation of wear in the cam and key lever holes without increasing key lever tension.
