ET News Letter

January 30, 1959

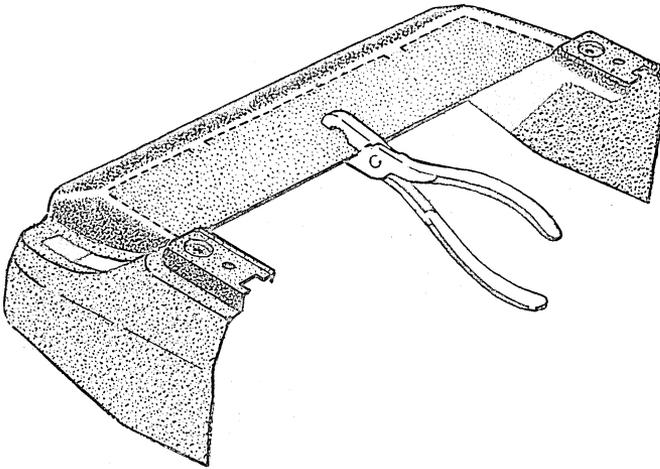
BREAK-OUT SECTION OF MODEL C CASE

Most manufacturers of automatic letter writing equipment, dictating equipment, and other office equipment attaching to typewriters, are making changes necessary to adapt their equipment to the Model C. For information concerning the brackets and/or other hardware involved, contact a local representative of the company concerned. A break-out section has been provided in the Model C lower case, however, to accept linkage from machines which operate the key-levers from below. This section can be broken out as follows: (NOTE: Wear your safety glasses - Be careful of sharp edges.)

1. Remove the bottom case section and turn upside down.
2. With gas pliers, or other heavy pliers, grasp the case at the center of the break-out section and push down forcefully until the metal breaks away. Continue to break away the case section to both sides, up to the "Score Line" in the case (See illustration).
3. After the metal is broken away as smoothly as possible, remove burrs and sharp edges with a file.

For a smoother break-out, a hack saw can be used to saw along much of the "Score Line".

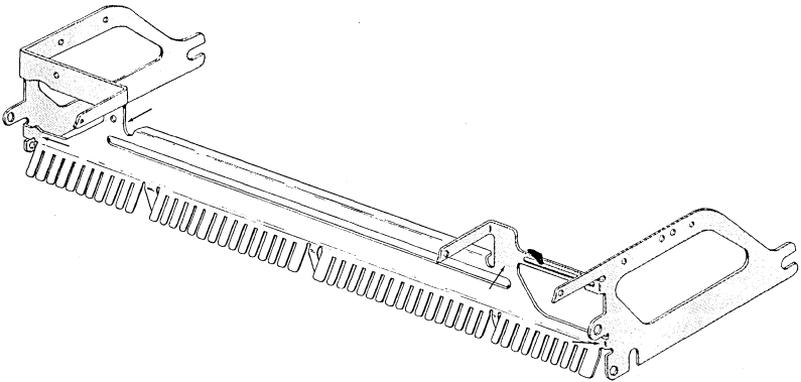
MODEL C KEYLEVER ALIGNING FIXTURE

A useful tool for holding key levers in alignment during bearing support removal can be made from a spare bearing support (part #1118217) as follows:

1. Cut the ends from the bearing support assembly along lines indicated by arrows in the illustration below.
2. File the cut surfaces to remove burrs and sharp edges.

By inserting this "guide comb" between the key levers at a point immediately in front of the key lever "adjusting lugs" and by inserting the small fulcrum wire through the pilot hole in the key levers, (small hole to the front of pivot hole) the typewriter bearing support assembly can be removed without disturbing alignment of the key levers. With this arrangement, it becomes a relatively simple matter to install another bearing support since the key levers can now be reconnected to it as a "unit".

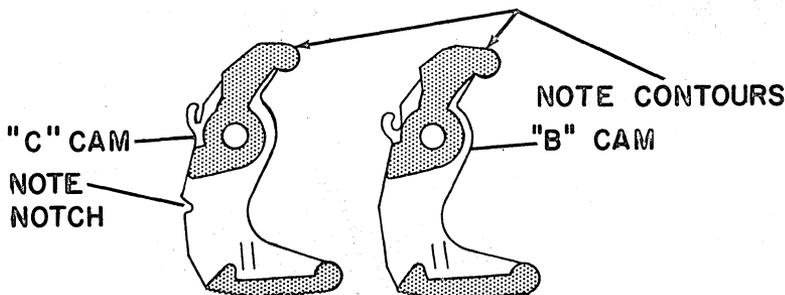
LETTER CAM IDENTIFICATION

The Model C & Model B letter cams have a different design contour at the trip lever contact point and when used interchangeably, may cause a touch problem. Model C letter cams can be identified by the notch in the rear of the cam and also by the trip lever contour as shown in the illustration below.

Model C cams used in Model B ET's result in a low tripping point and, in some instances, the keylever will bottom in the guide comb before tripping the cam.

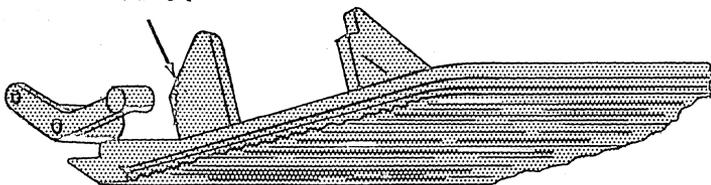
TOP COVER INTERLOCK NO. 1118331

Where breakage of this part is a problem, it may be helpful to lengthen the interlock connecting link. CAUTION: Insure that the sensing finger fully engages the opening of the spool hub when the top cover is closed.

On certain machines it will not be possible to adjust this condition out without affecting ribbon reverse. On these machines interlock breakage can be eliminated by removing material from the bottom of the interlock camming surface as indicated by line A in illustration above.

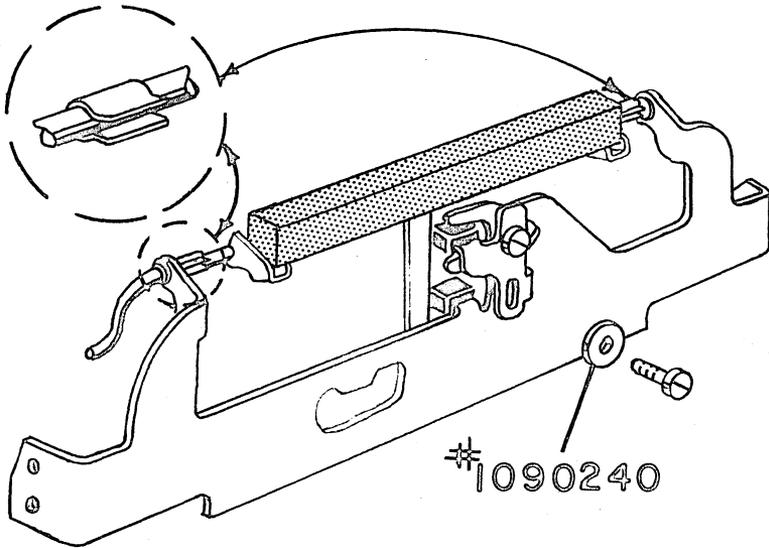
NEW RETAINER USED ON "C" SPACEBAR

Retainer clips (Part #1110093, used to hold feed rolls in position on feed roll shaft) are now used on the Standard Model C spacebar shaft, in place of the neoprene sleeves, to reduce lateral motion of the spacebar keybutton. The retainers are placed on the inside of the bracket which supports the spacebar shaft. (See illustration above)

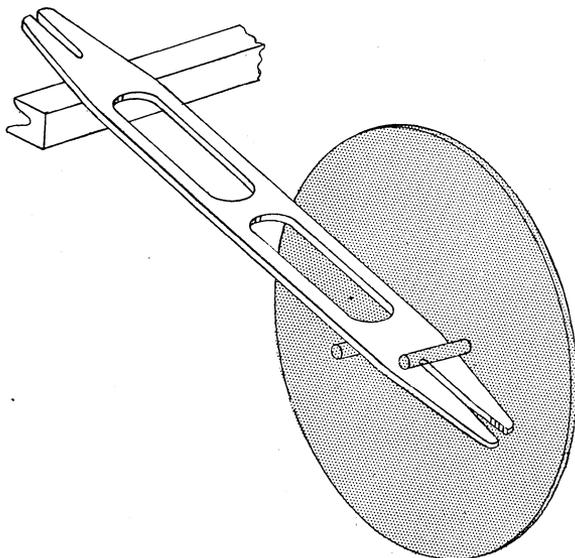
ADJUSTING "C" RIBBON TAKE-UP

If carbon ribbon breakage is a problem between the feed rollers and the take-up spool, check for excessive rewind torque. (Torque beyond 150 grams, measured at the 1 inch diameter of the empty spool, is considered excessive). An easy check can be made by installing the latest style aligning wrench, #9504487, into the spool as illustrated. (NOTE: The end with the deepest slot should be inserted between the hub and pin so that the end of the slot is covered by the top peg). If the torque is in excess of approximately 150 grams, the weight of the wrench hanging toward the rear will not be sufficient to prevent rotation of the take-up spool.

Where excessive torque is a problem, reduce it by one or more of the following steps:

1. Reduce the length of the fabric clutch spring cover if it appears to be too long. A cover that is excessively long will result in added drag between the driving and driven members which in turn will result in added rewind torque.
2. Eliminate any bind or burrs and check for proper lubrication. (Molycote is a satisfactory lubricant for this mechanism).
3. If steps one and two do not help, replace the spring and/or hub.

NOTE: Cutting coils from the spring and polishing the hub are not recommended procedures since they are not appreciably effective in reducing take-up torque but frequently result in varying or pulsating tension.

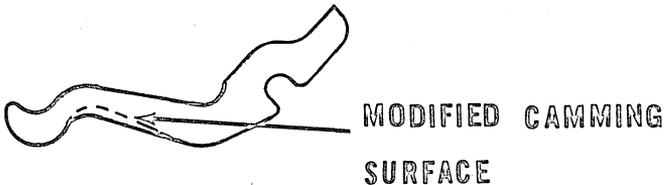
IMPROVED "C" BAIL

The Model C paper bail pressure arms have been modified to insure restoring of the paper bail to its rest position. The camming surface of the left and right hand spring-loaded pressure arms have been modified as shown in the illustration below. The bail arm rollers have been slotted to keep the pressure arms on the roller. Part numbers of the pressure arms and paper bail arms remain the same.

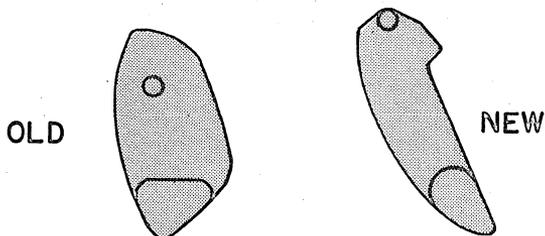
RIGHT HAND RIBBON SPOOL GATE

On machines prior to Serial No.1116531 the gate of the R.H. Spool Assembly was very blunt. Occasionally the right sensing finger would ride over the gate instead of reversing. This has been corrected as shown below. If this problem is encountered, the R.H. spool assembly Part No.1118359, should be replaced.

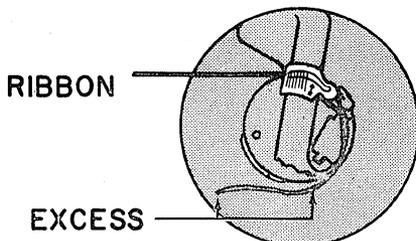
PROPER RIBBON INSERTION - PLASTIC CLIP

Ribbon reverse failure can occur if too much ribbon is pulled beyond the plastic clip. The end of the ribbon will block the gate and prevent the sensing finger from entering and reversing the ribbon.

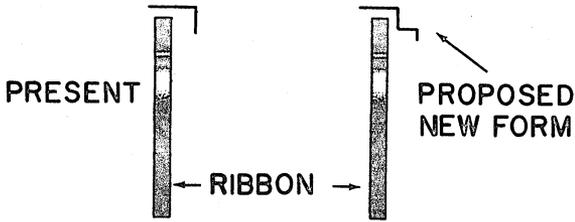
CARBON RIBBON TWISTING

It has been found that a twist develops in the carbon ribbon due to a loop of ribbon falling off the supply spool as the ribbon is fed. This can be eliminated by forming the supply follower, #1117730, where it rests on the supply spool. Form this follower to conform to the ribbon. This is done by making two right angle bends near the right extension.
