## Chapter 6

### DEC/VAX 7xx0/10xx0

Revision: Written July 1993, updated January 1994, August 1994, April 1995.

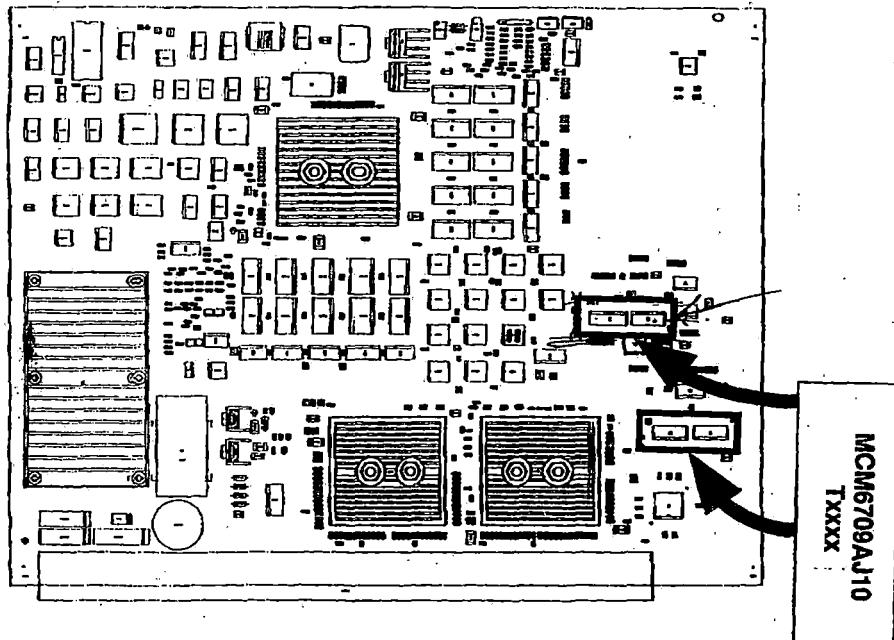
Front:

The chips to look for are marked in the drawings. There are four on the front of the module and five on the back. *If* the chips are marked MCM6709A10 *and* the build code begins with "T", they *are* defective and the module should be replaced.
