## Chapter 14

## QBUS SYSTEMS

### 14.1 QBUS CONFIGURATION and Part Number Guide

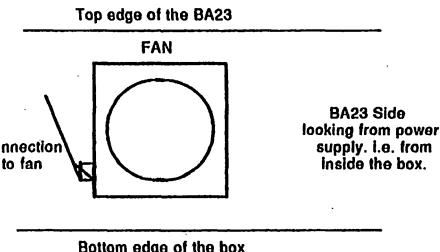
Figure 14-1: BA23 Fan Connections

### 14.2.1 BA23 Fans connected wrong - cause memory failures

The fans on a BA23 (12-17556-01) are both the same and are DC fans. If connected the wrong way round they do not suck instead of blow, but do not turn at all. The fan at the front of the BA23 is not so important and can easily be seen to be rotating. However the power supply fan is very important and causes the box and QBus options to overheat. It is the memory that is the first to suffer from heat. The fan is difficult to check visibly, but like any fan it is permissible to poke a bit of paper into it to check for its rotation.

As long as they are connected as in the following diagram they should turn the right way. If you are tempted to leave the connections to the top of the BA23 (so being easier to connect) then they will be wrong.

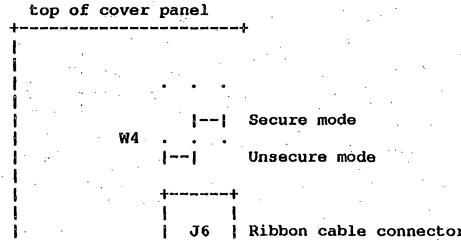
For either method, a jumper on the H3604 (cover panel) module must be set in the "unsecure mode".

Jumper: There are two little black jumpers on the backside of the H3604 cover panel.

The bottom jumper of the two needs to be moved so that it covers the two posts for unsecure mode to enable the ROMs to be blasted.
