Chapter 22

TAPE DRIVES

Chapter written by Brian Hailstone and Jim Egginton and lately edited by Dave Bazley . . .

Chapter revision information : Revised August 1993 and November 1994

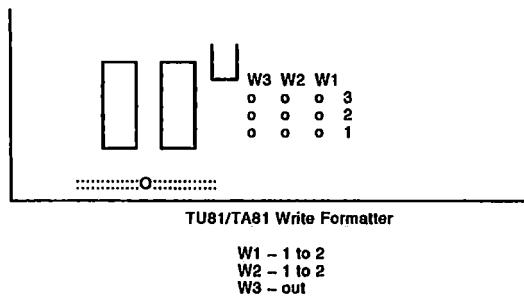
Figure 22-1: Write formatter

There is more than one version of the Tx81 write formatter PCBA (29-24708) and the layout and position of the jumpers are different. The pocket service guides show one layout and Figure 22-1 shows another.
