# Diskette Drive Modifications

# TEAC 55A, 55B, 55C, 55D

MATCHPOINT-PC Drive Modifications**CHINON F-502L, FZ-502** (Reading APPLE data)

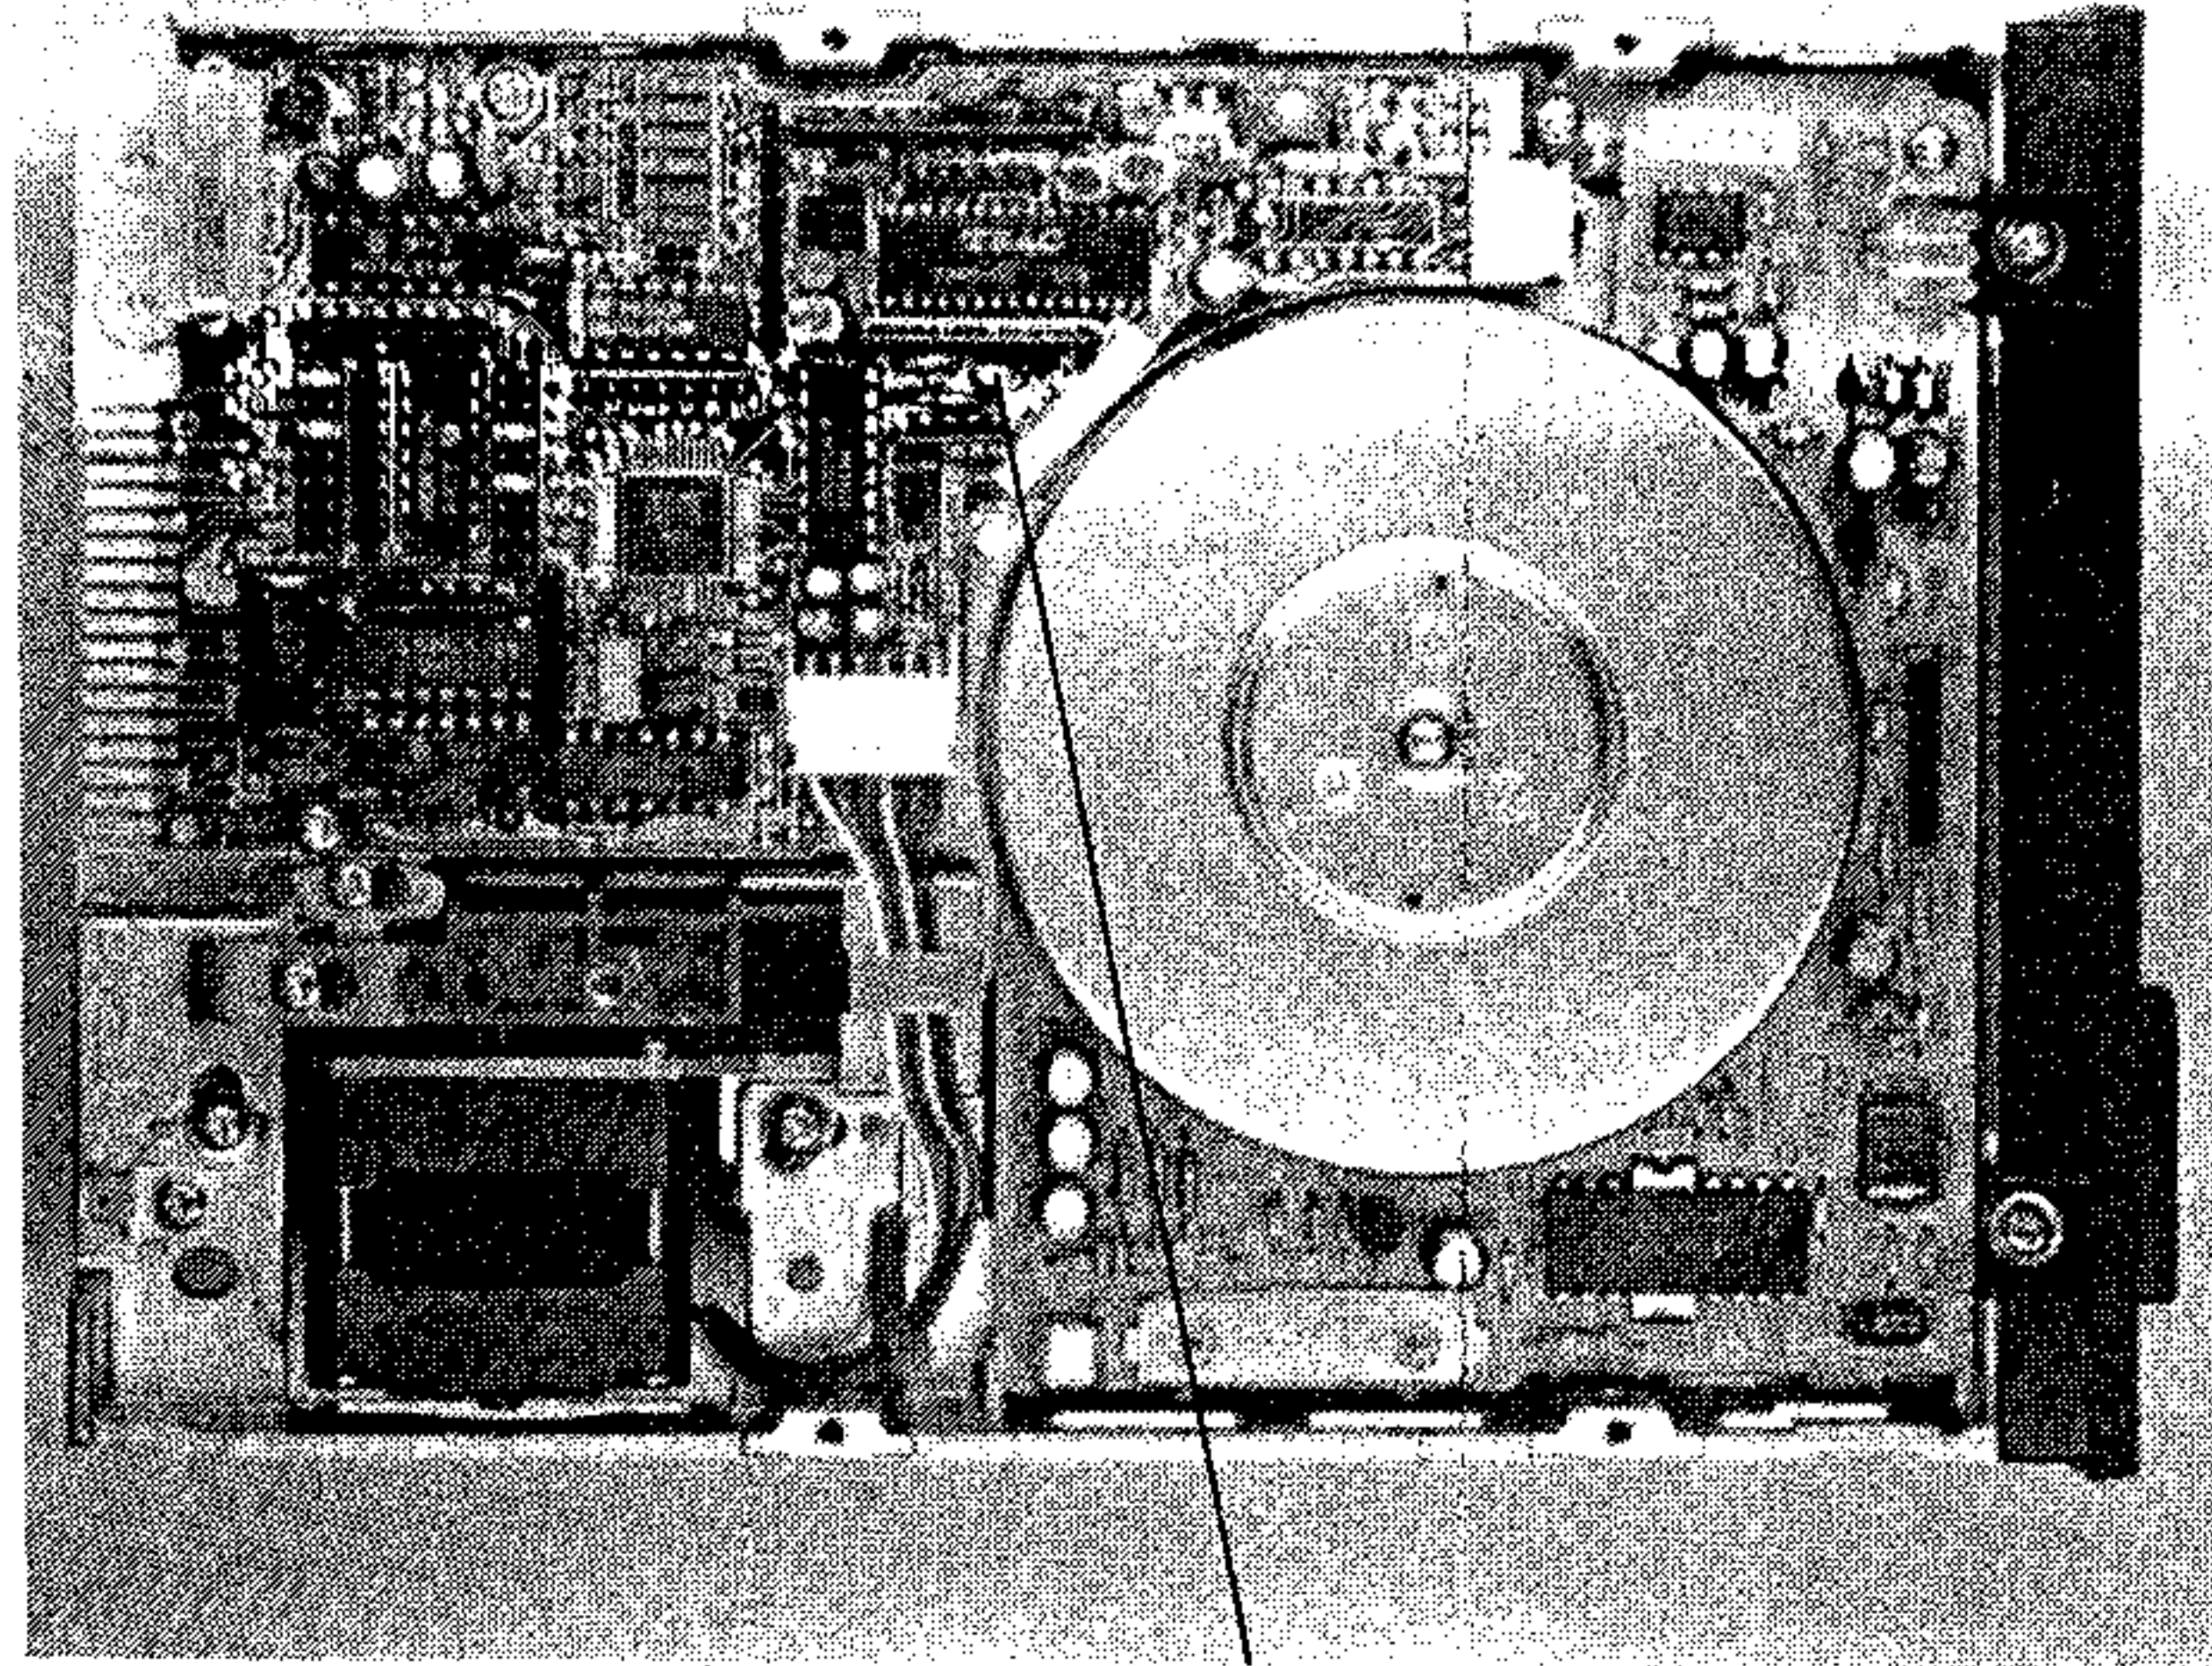
TEAC disk drives must be modified before they will work properly with MatchPoint-PC. This modification should be performed by a qualified technician since it involves replacing a capacitor on the drive electronics board.

- 1) Remove the disk drive from the computer and position it in front of you as shown in the next photo.

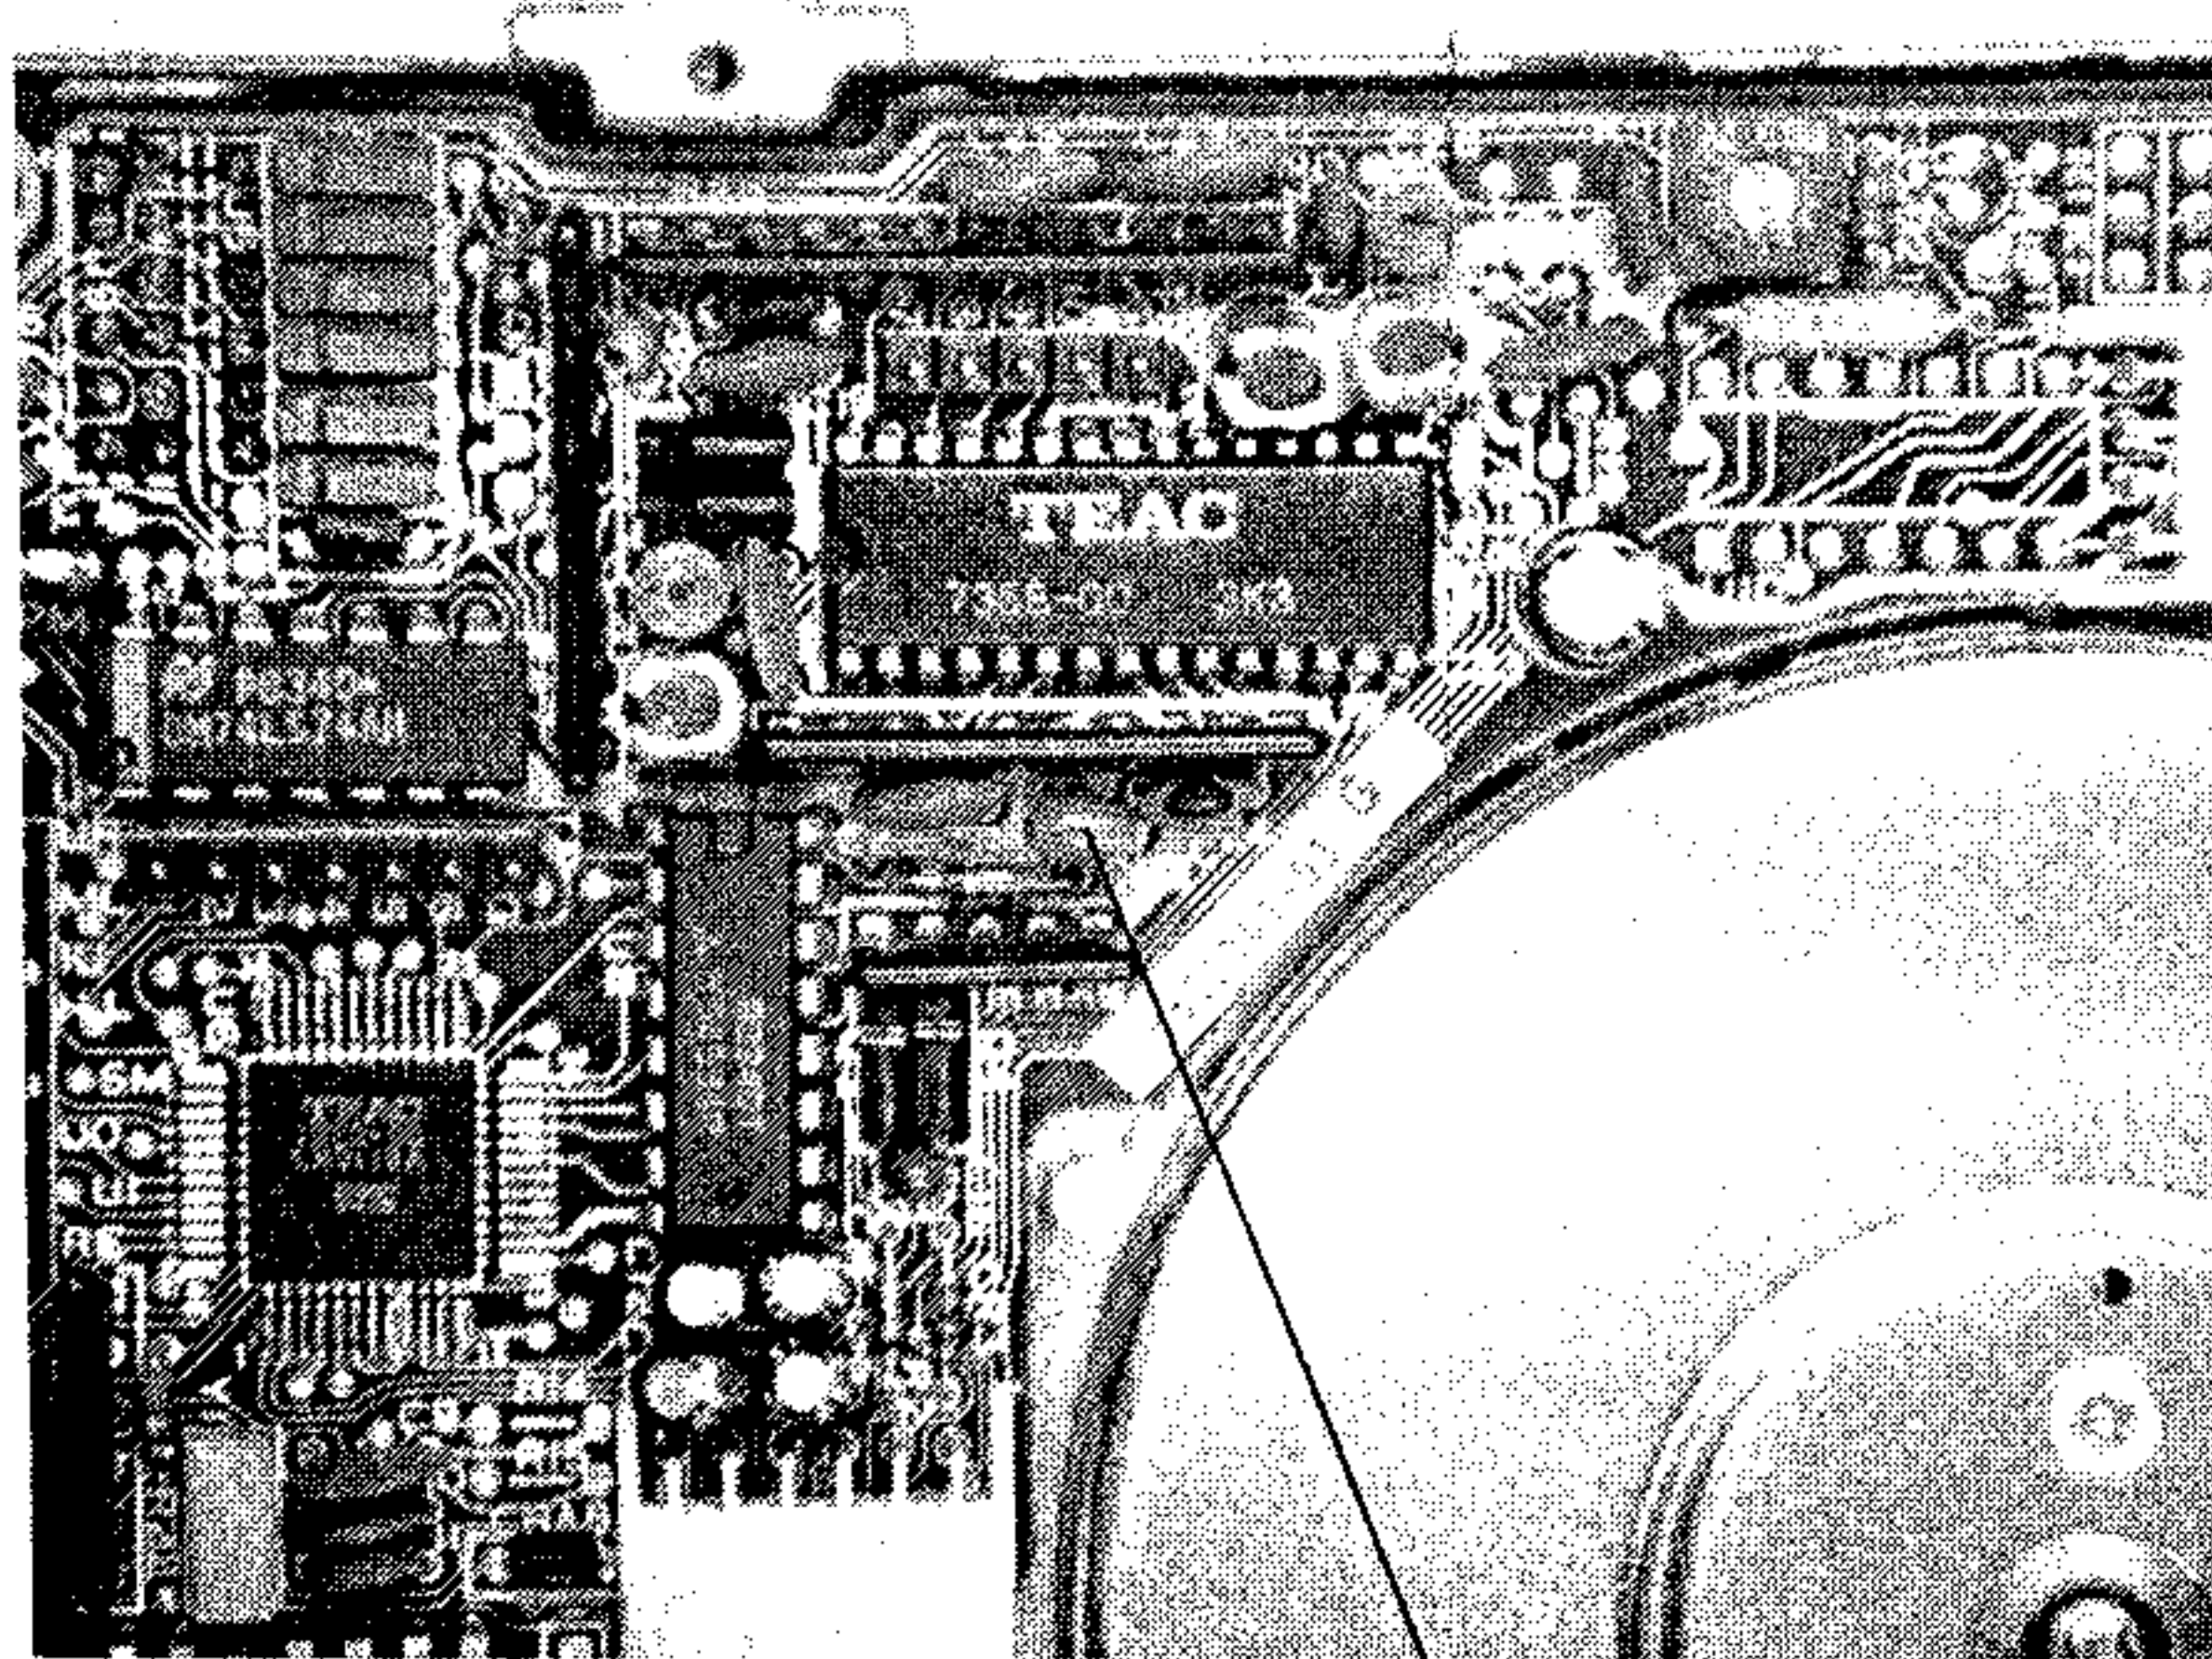
- 2) Locate capacitor C23 on the drive electronics board. The next photo shows C23 and the surrounding components.

- 3) Carefully remove the drive electronics board from the drive chassis.
- 4) Remove C23 and replace it with a 140 pf capacitor.
- 5) Install the drive electronics board back in the drive chassis.

- 1) Replace 100 pf capacitor at C23 with 140 pf capacitor, or put 39 pf capacitor in parallel with existing C23.

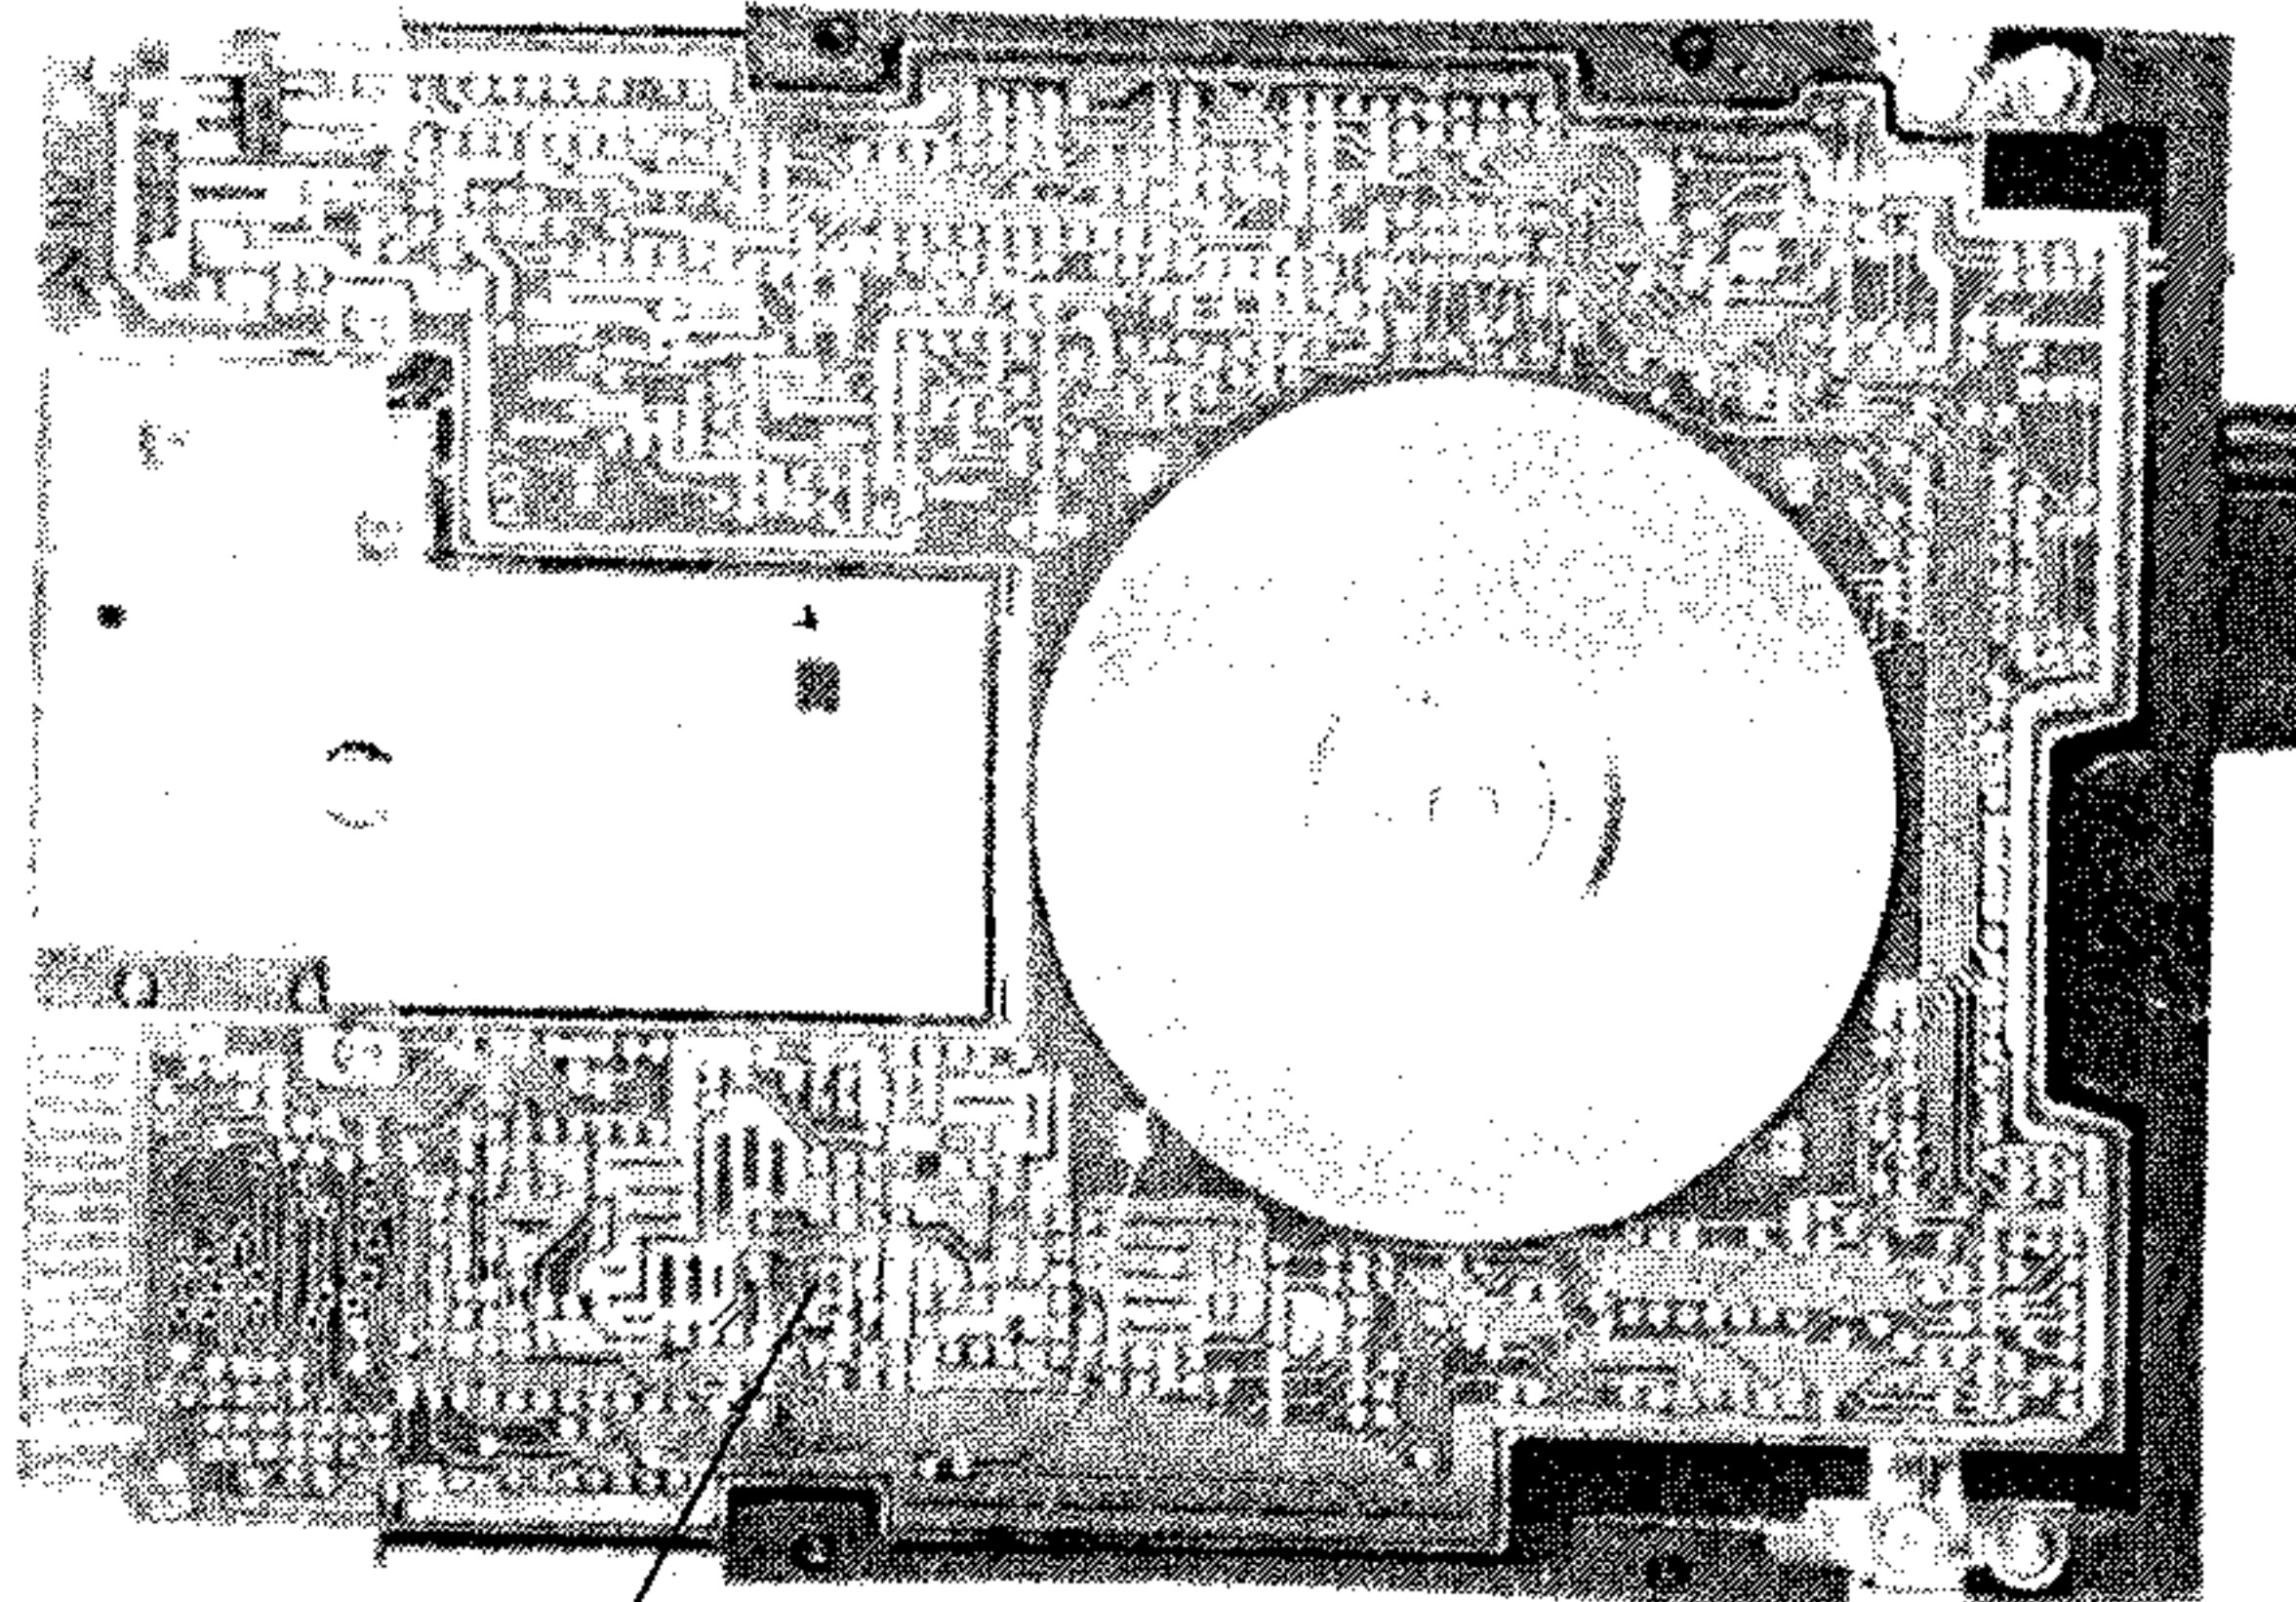
New Capacitor

OKI disk drives must be modified before they will work properly with MatchPoint-PC. This modification should be performed by a qualified technician since it involves the addition of a capacitor on the drive electronics board.

- 1) Remove the disk drive from the computer and position it in front of you as shown in the next photo.

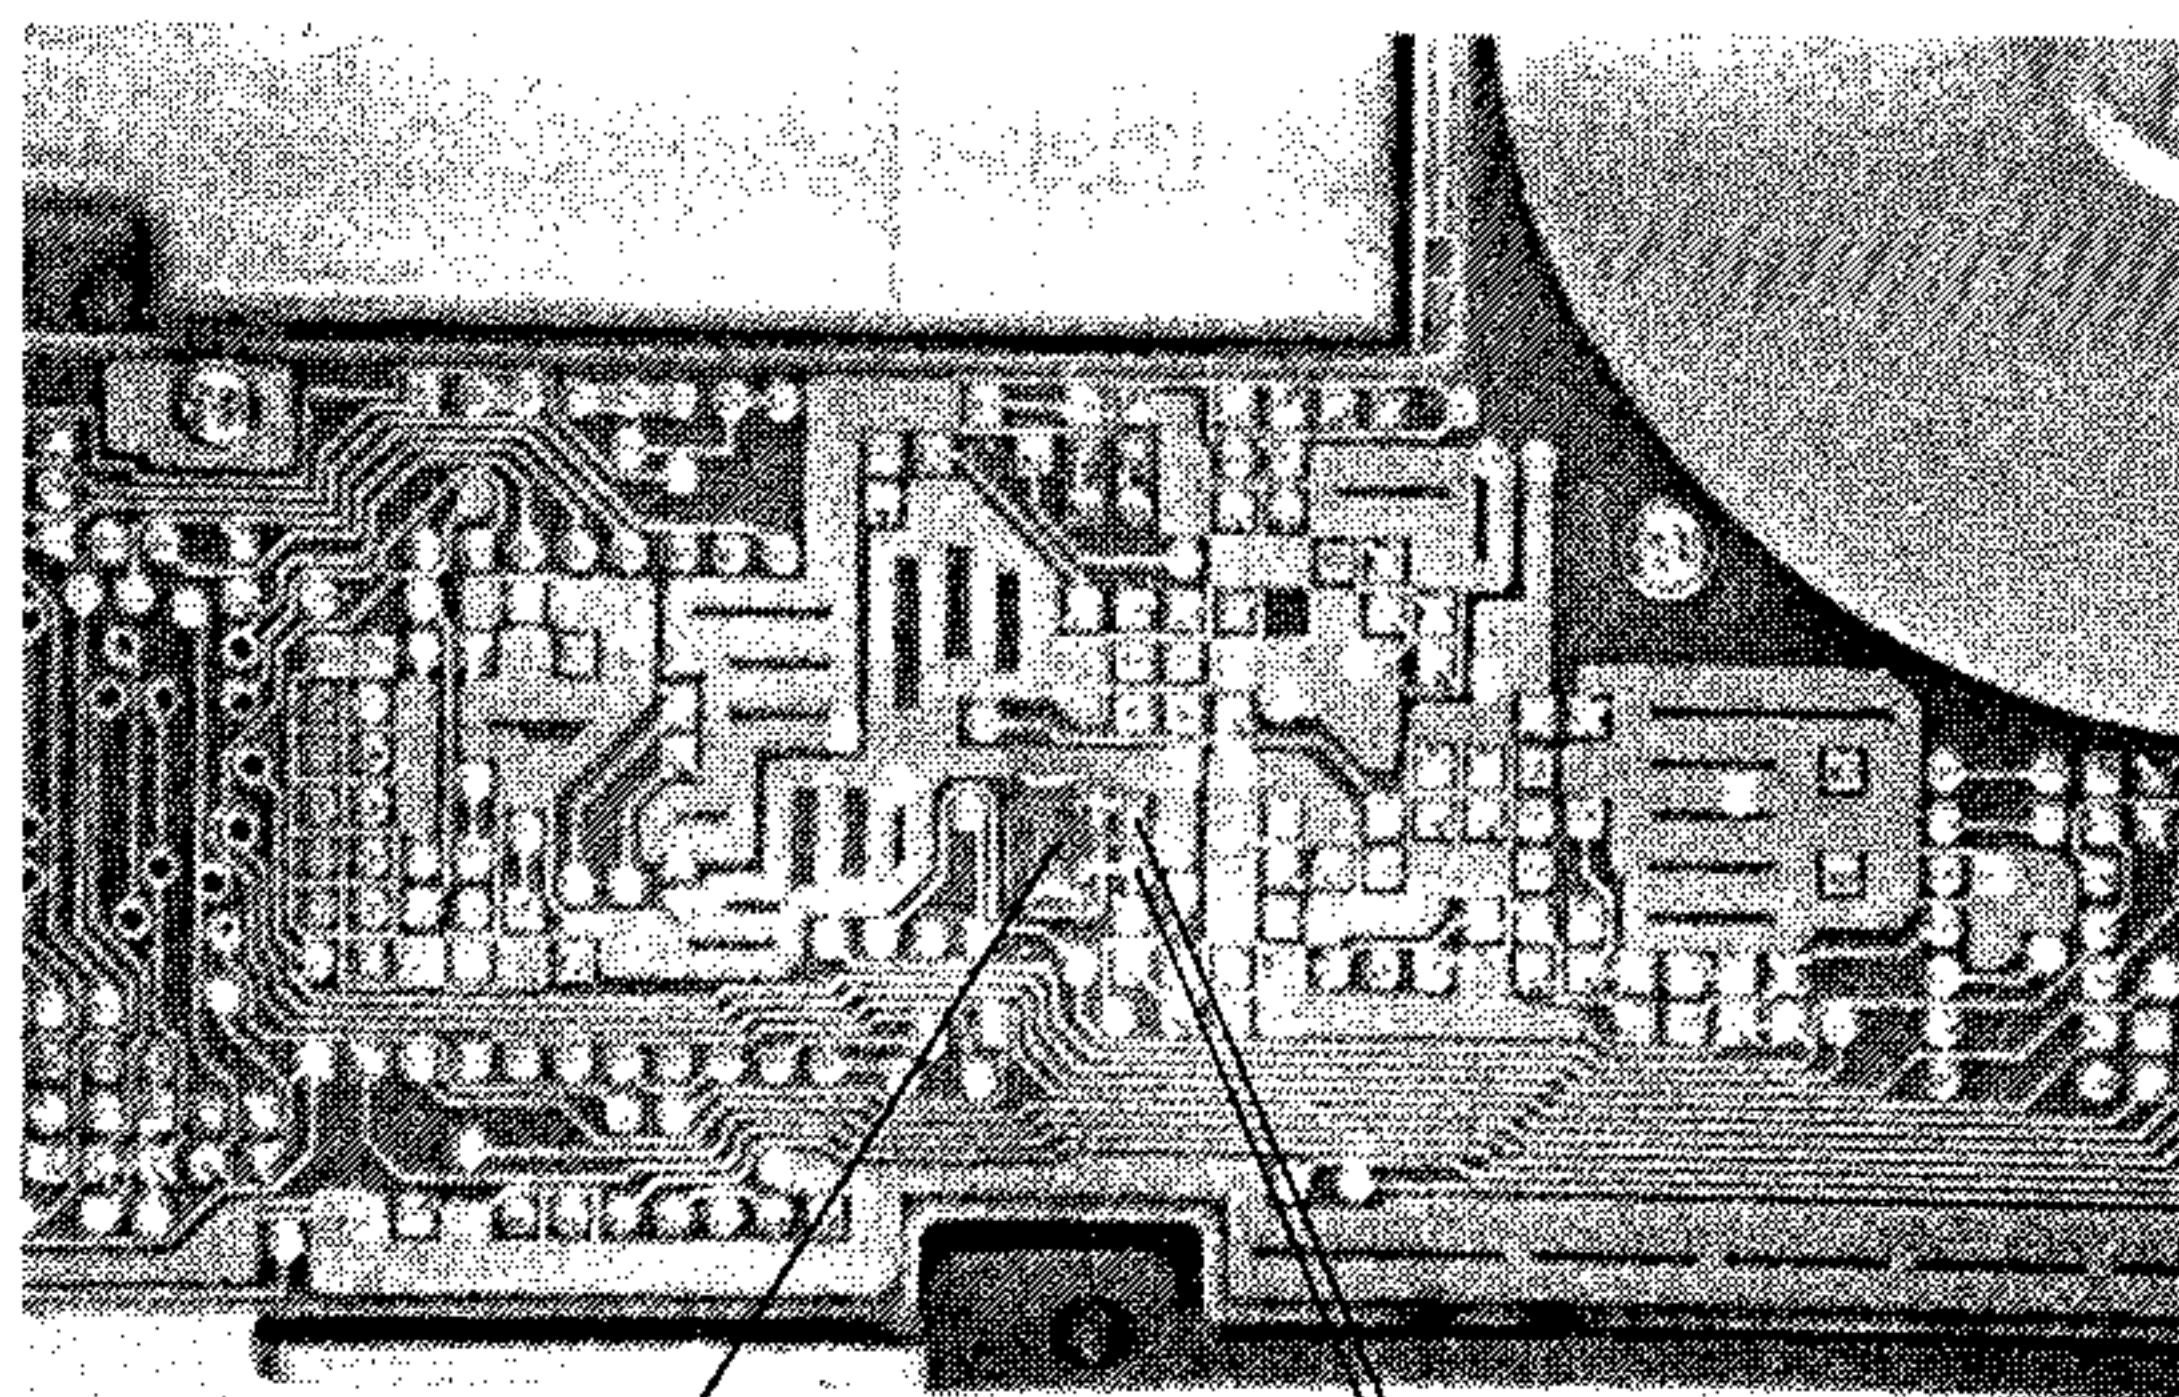
New Capacitor

Solder leads here

- 2) A 240 pf capacitor must be soldered to the drive electronics board. Use the following photo to locate the area where the capacitor is connected. The capacitor leads are soldered to the two pads just to the right of the new capacitor. Use the next photo to locate the proper position.

- 1) Install 240 pf capacitor according to photo in mod sheet.
