CUSTOMER ENGINEERING

# news LETTER

January 31, 1956

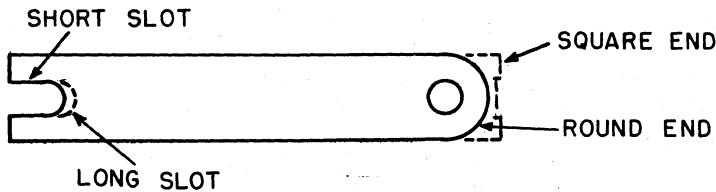
Several changes are now in effect which should reduce spring breakage considerably. The depth of the slots has been reduced to allow more stock between the slot and the area where flexing occurs. The rear shim (#1077799) is rectangular to equalize the strain across the slotted area of the spring. Front shims (#1104493) are of a circular slotted design. When replacing segment guide springs, the rear rectangular shim should be installed wherever the former partially round shim is found.

WHERE USED				DESCRIPTION *			
Serial No.	Model	Seg. Supp.	Upper or Lower	Part No.	Slot	Hole End	Form
Above 169156	Std. & L. P.	Cast	U & L	1107959	Long	Round	None
Above 22300	Exec.	Cast	U & L	1100980	Long	Round	1/8"
90000 to 169156	Std. & L. P.	Cast	U & L	1071718	Long	Round	1/16"
Prior to Spring Rest	Std., L. P. Exec.	Cast	L	1072934	Short	Round	None
Prior to Spring Rest	Std., L. P. Exec.	Cast or Steel	U	1073870	Short	Square	3/32"
Initial Model A	Std., L. P. Exec.	Steel	L	1071719	Short	Round	1/16"
