ET News Letter

January 30, 1959

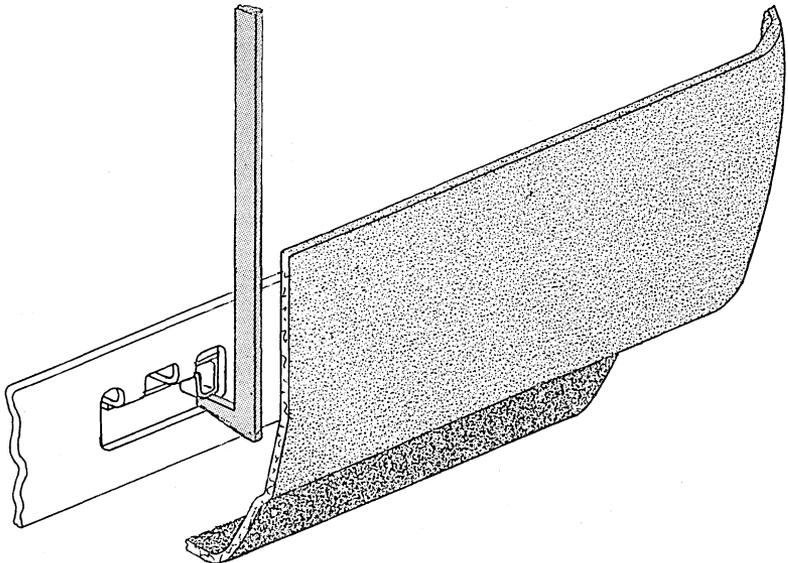
One end of the TKO Bender (Tool #9504486) has been modified to permit its being used to adjust the spacebar adjustable spring support (Part #1117916) on Model C Standard ET's. By placing the tool in the hole provided in the front frame, as shown in the illustration, the adjustable support can be easily formed upward or by placing tool in U portion of the support can be formed downward as desired without removing the bottom cover.

This tool modification can be made to your TKO Bender by grinding the tool to the dimensions as shown in the above illustration.
