## Chapter 1

### VAX 6000 CALYPSO series

This chapter assembled by Pete Griffin, JAN'93

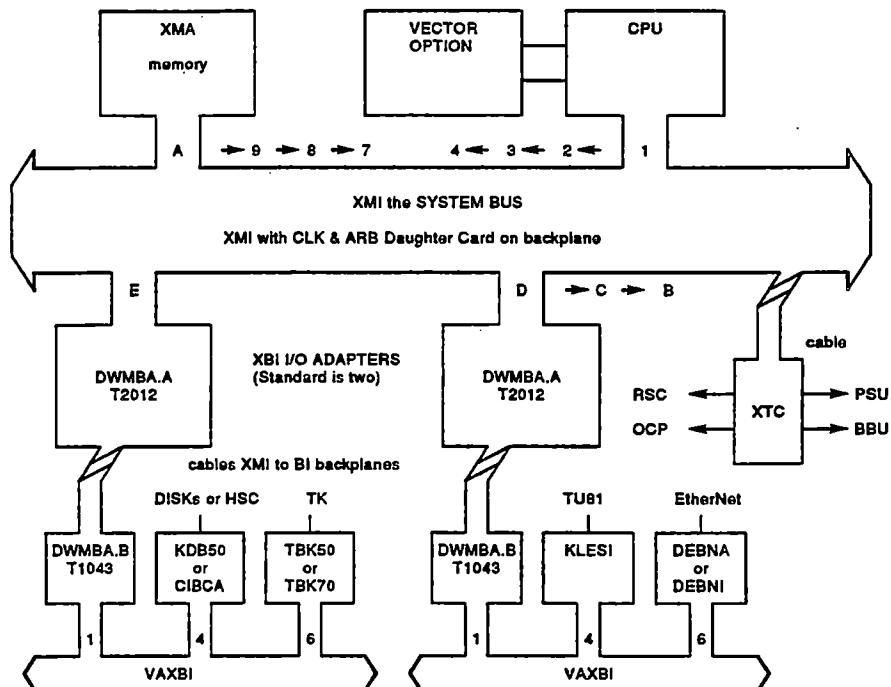
Figure 1-1: Original CALYPSO Block diagram

The Original Platform (in its Standard Form) had two XBI adapters as shown above.

The New Platform (in its Standard Form) has no BI buses, and uses I/O adapters on the XMI.

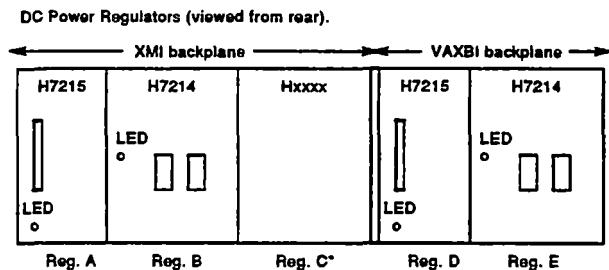
**Figure 1-2: PSU layout**

Outputs are as Regulator A, but used "as you like" by BI nodes.

\* Reg. C is a H7214 on an old platform, H7242 on a new platform.

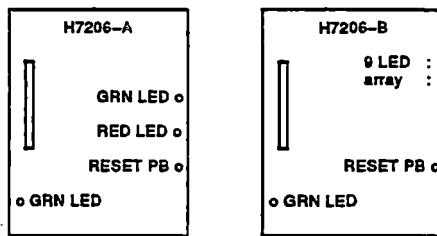
H7206 Power And Logic unit (viewed from front) – known as the PAL BOX.
