## Chapter 4

### 11780 and 11785

## 4.1 Engineer's view of system blocks

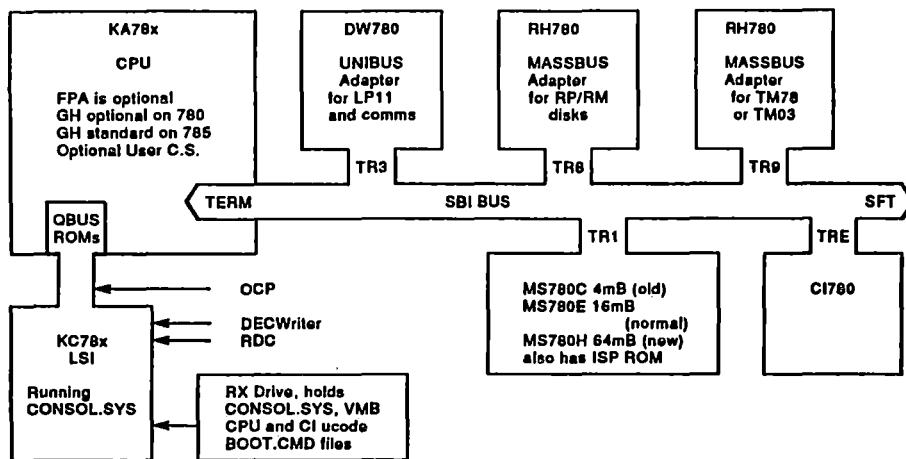
Figure 4-1: Functional block diagram

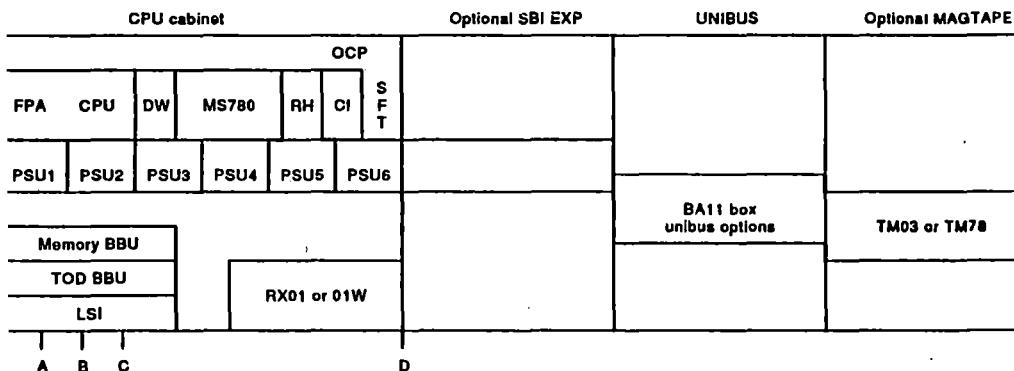
Figure 4-2: System layout

A - Round the back, Transition piece for ROUND massbus cables to disk or TM78.

B - Round the back, CI cable connections.

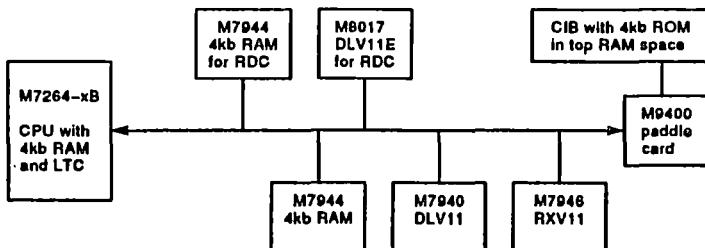
Original configuration

**Figure 4-4: LSI block diagrams**

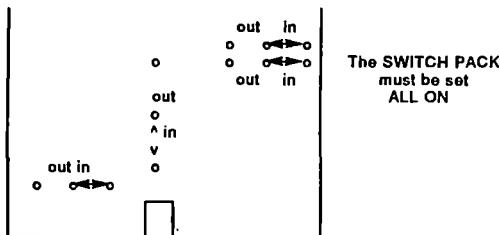
Figure 4-5: New memory setup (M8044-EB)

The new memory module is a M8044-EB. When this module is used NO OTHER memory is allowed in the LSI. This means you must remove all the 4kb memory modules and the 4kb on the CPU module.

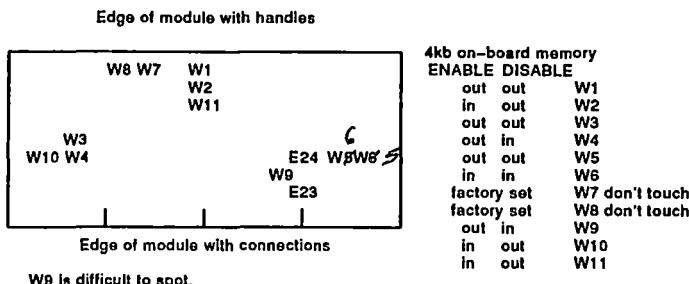
Figure 4-6: Old CPU setup (M7264-BB or -EB)

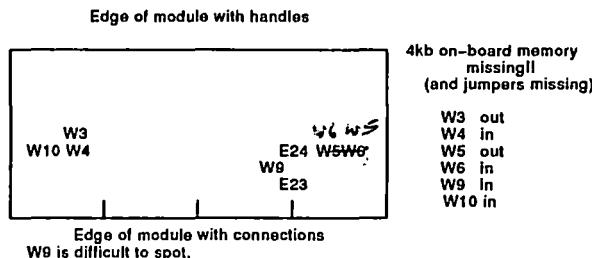
Figure 4-7: New CPU setup (M7264-YC)

For QBUS continuity, the modules have to be in the correct sequence in the backplane.

The top row of four slots is row 1, the rest are labelled 2, 3 and 4.
