Chapter 5

8600/8650

5.1 reference information

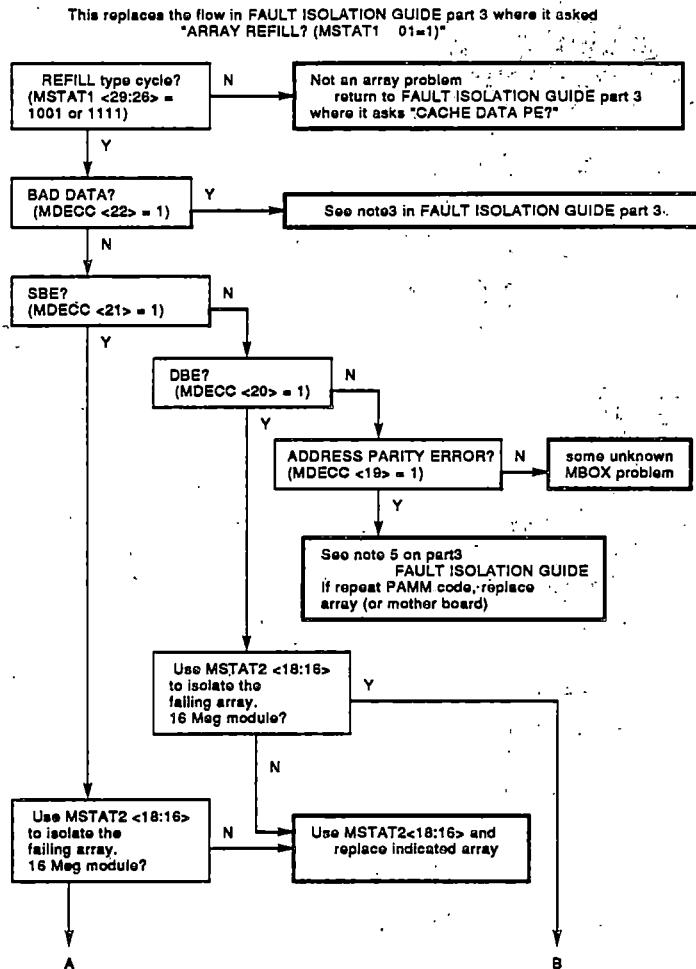
Figure 5-3: New Memory Fault Isolation flowchart.

Figure 5-3 Cont'd. on next page

The 16mB arrays consist of a L0225(motherboard) and eight 54-16500-AA or -AB's (daughter boards - also called SMU's). Put 16mB boards before 4mB boards. Maximum configuration is 4x16mB plus 1x4mB. Diagnostics and VMS4.3 call out the failing SMU where applicable.

The SMU part number 54-16500-AA has been replaced with a lower-power version, 54-16500-BA. Both versions are interchangeable, on the L0225, and can be mixed. VMS V4.3 or greater will put the array type code in MSTAT2 < 27:24>, but do not expect a machine check logout or snapshot file to contain valid information in this field. This chart pertains directly to information that ERRFMT has got its hands on, i.e. an ERRLOG entry. If you are getting your register data from a machine check logout or snapshot file, just take the fork, when you get to it, which says the array-type-code information is valid.

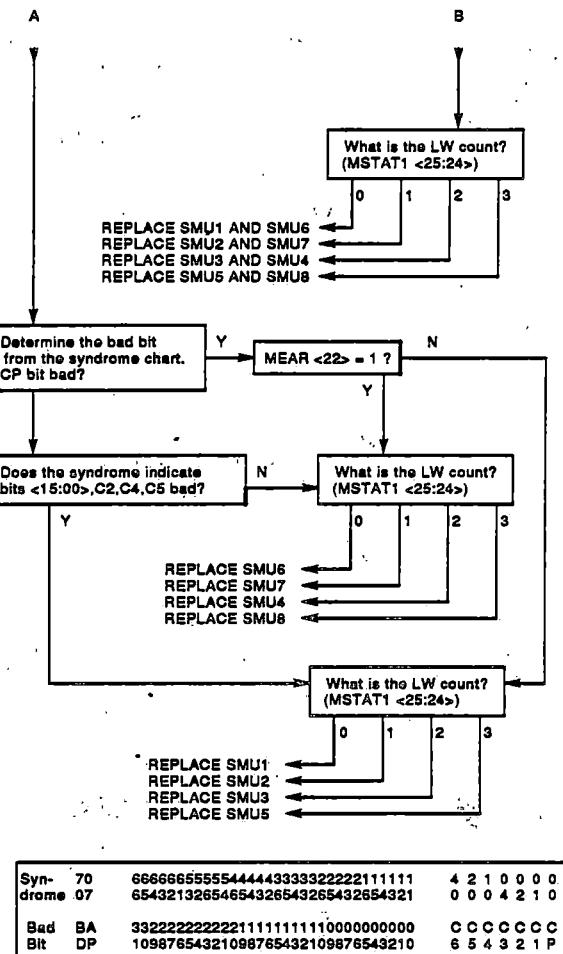
Figure 5–3 (Cont.): New Memory Fault Isolation flowchart

Note: The syndromes shown are in "OCTAL" and are contained in MDECC <14:09>
