## Chapter 8

### 82/83x0 and VAXBI

Revision: Reorganised and updated January 1993

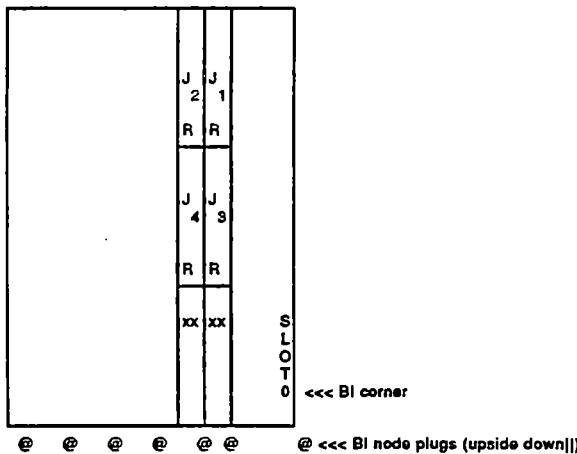
BA32 82xx CPU box      RX50 slots

Red stripes to the right.  
Looking at the "1" side (normal chip side)

R = Red stripe. xx = Unused.

The cable loom supplied will only go one way round. The connectors are keyed and marked.
