Chapter 26

FCO Information

26.1 About this chapter

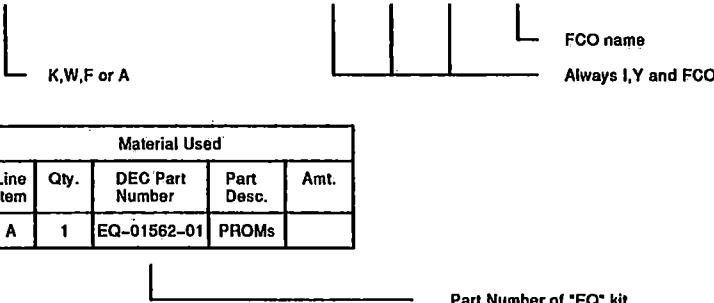
Figure 26-1: FCO LARS example

Act.	Repair Time	DEC Option	Serial Number	Type of Call	Action Taken	Fail Area
*	**	LG03	8701234	I	Y	FCO LG02-F003

FCO name
 Always I,Y and FCO
 Part Number of "EQ" kit

NOTE: This information is included in all FCO documents.

1. All FCO calls should be logged.
2. Written LARS are no longer required for FCOs, however use of the correct codes is still essential. (See Figure 26-1).
3. The details should be phoned in to your Resource Controller as soon as the call is complete.
4. The Fault Label (on the returned parts) must be filled in as follows. No other combination should ever be used.
 - Part Number = EQ-nnnnnn-nn
 - Activity code = K, W, F or A. (Y is dead!)
 - Product line = 111
5. For certain options we can also report repairs as FCOs, and charge parts and labour to Product Line 111, even though an FCO does not apply. See Factflash "PL111 List - Cost Relief" for lastest details.
