IOU-32, 42, 52 ERROR STATUS'

BEST ERROR 83 - PSEUDO DISK STATUS'

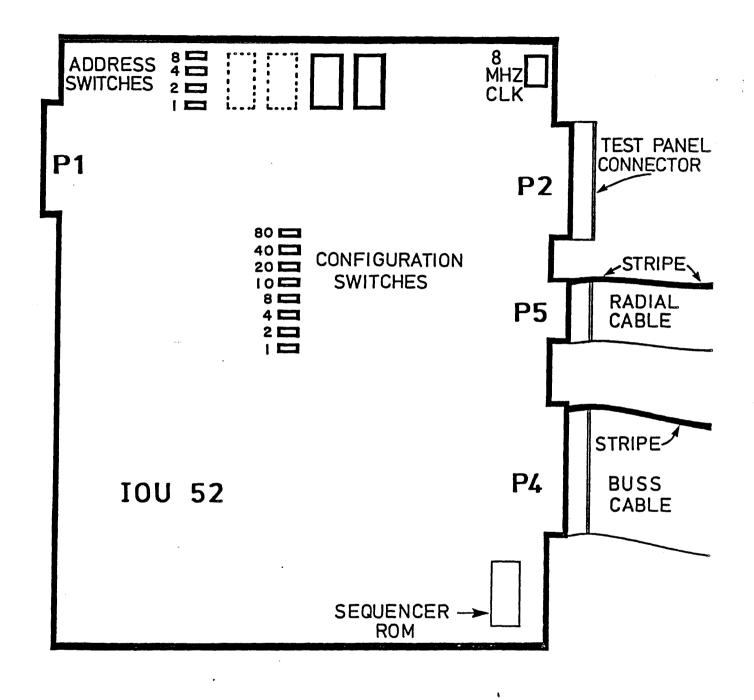
Figure 2-1

100'52 CONFIGURATION SWITCH SETTINGS

The setting of the configuration switches (see Figures 2-1 and 2-2) depends upon the disc drive being used with the IOU 52. Use the following table to set the configuration switches:

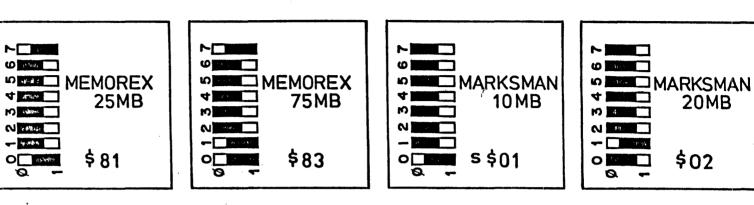
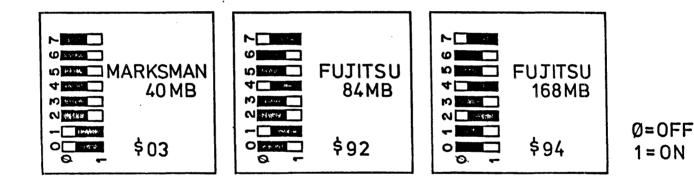
Figure 2-2

Sequencer ROM	Memorex	Fujitsu & Marksman
Label	42 MEM(y)	42 MRK(y)
MDS PART NUMBER	041 405 301	041 405 401

y = Rev level

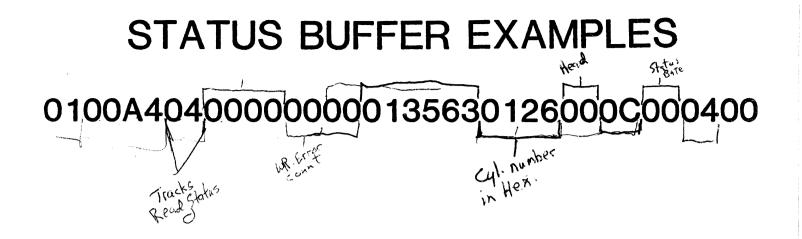
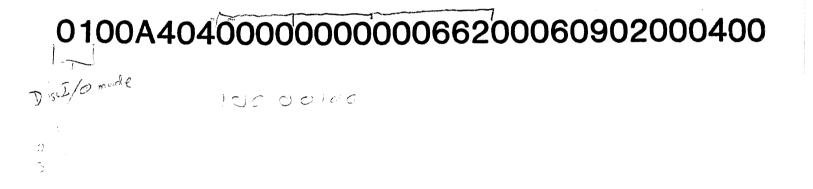
- BYTE 3: Must be broken down into binary for decoding. Only the upper three bits of the upper nibble have been defined.
- BYTES 4 & 5: Hex error count for the last read operation.
- BYTES 6 & 7: Hex error count for the last write operation.
- BYTES 8-10: The Logical Sector Address of the last operation IN HEX.
- BYTES 11 & 12: The cylinder number (in hex) of the last operation.
- BYTE 13: The head number of the last operation (hex).
- BYTE 14: The rotational sector number of the last operation (hex).
- BYTE 15: This hex number must be broken down in the same fashion as the example of BYTE 2.
- BYTE 16: Is the Interlace Pattern. Example: 04 on an IOU-52 indicates that the drive was formatted on a Q30 processor. 05 = Q29 03 = Q64
 - On an IOU-54 (EAGLE ONLY) the interlace patterns are; Q64 = 4, Q30 = 10, Q29 = not currently supported.
- BYTE 17: Currently always 00.
